Inspector's Daily Report

IDR Sheet	1	of	1	Sheets	Final Record Book	Page
Contract	C-7852			Day	Wednesday	
				Date	June 1, 2011

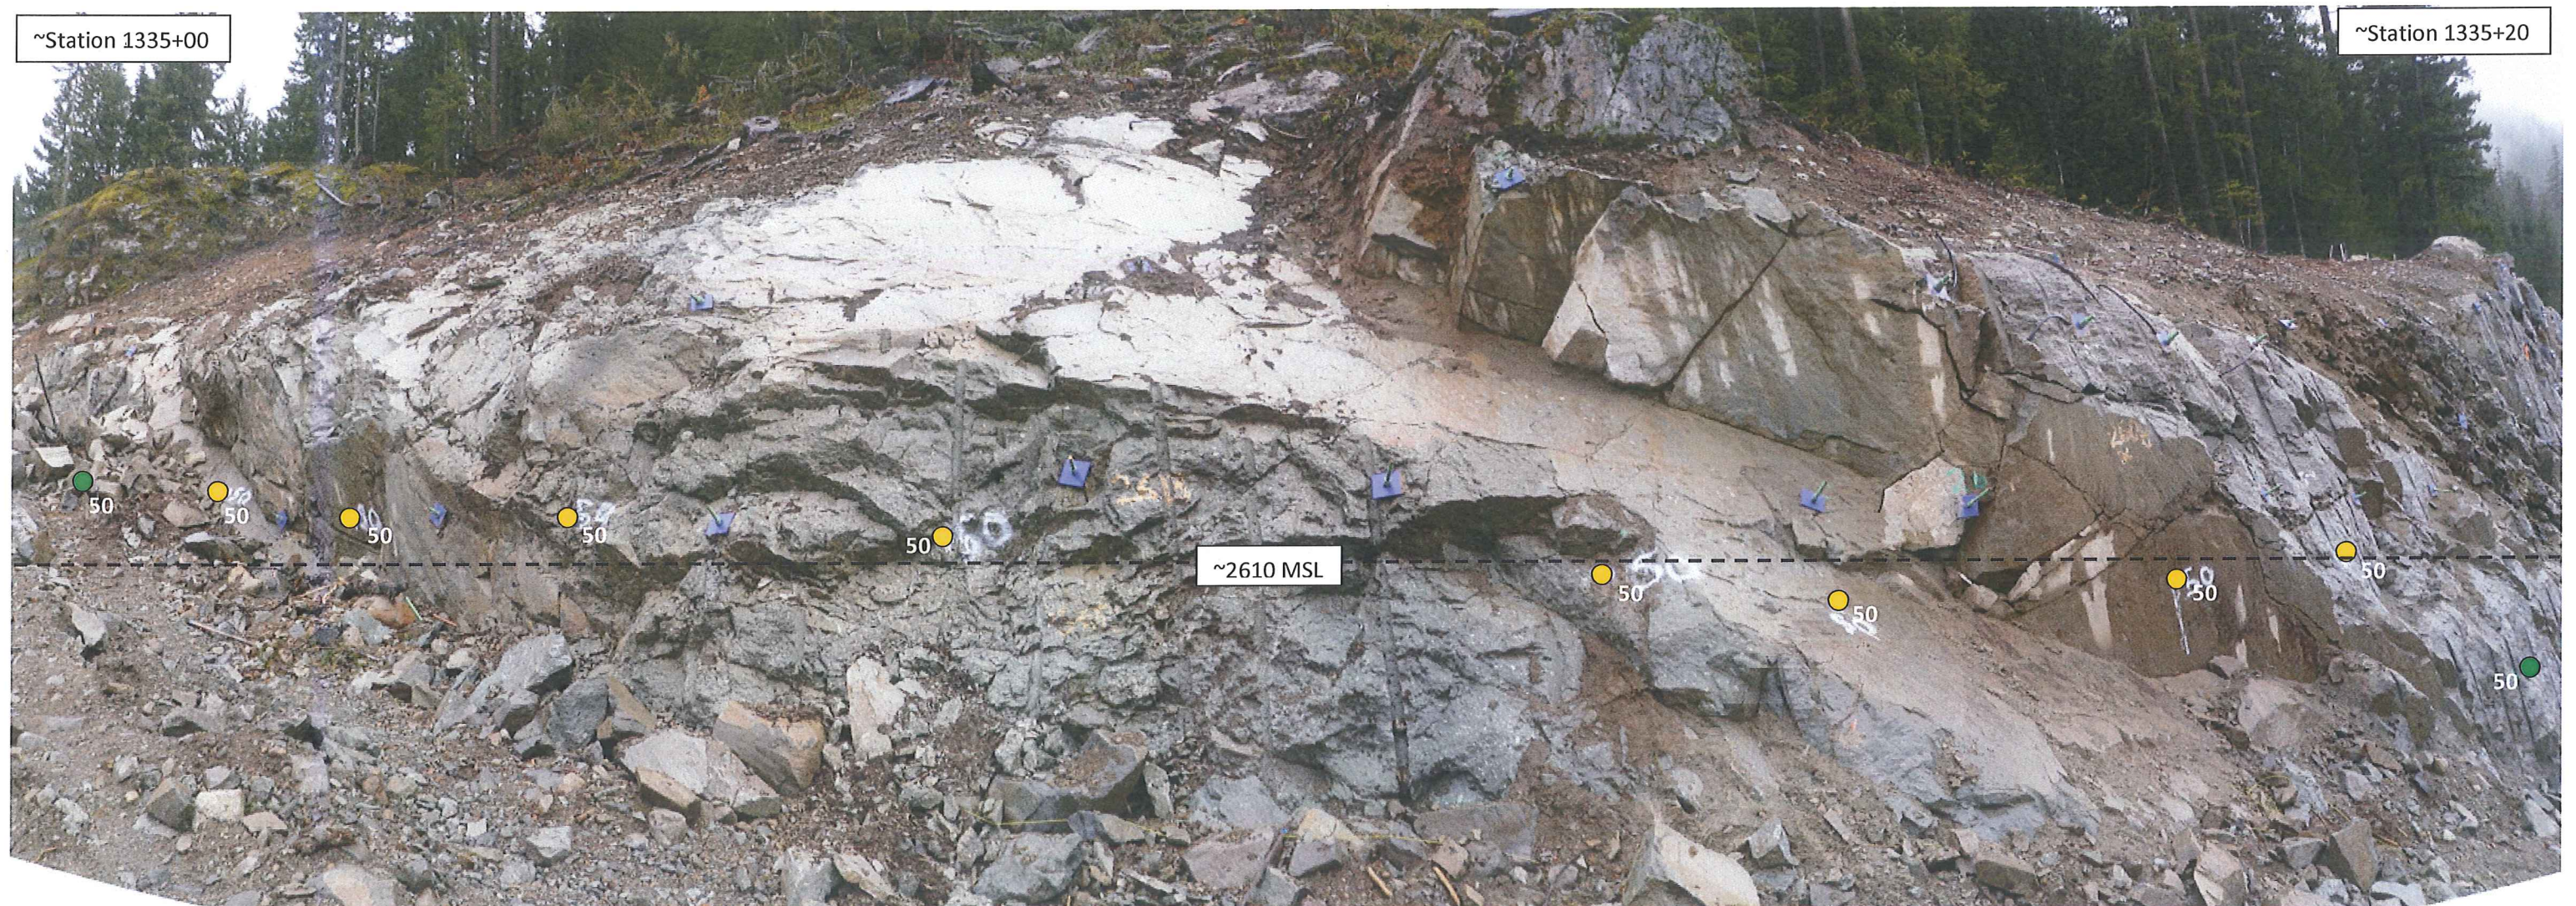
I arrived at the Hyak office around 9:00 am and met with Brad Schut (WSDOT Inspector). Brad and I drove to the east side of the project to lay out eight Type H Rock Dowels from approximate station 1335+00 to 1336+20 at approximate elevation 2610 MSL (Figure 1). The intent of the additional Type H Rock Dowels is to stabilize the large, highly persistent structure that was exposed late in last year's construction season. Both slopes on either side of this area were excavated earlier in last year's construction season and Norm Norrish produced a memorandum dated August 2, 2010 and an IDR dated September 9, 2010, detailing the additional rock anchors needed to stabilize the large, highly persistent structure exposed at both locations. This current layout will fill-in the gap to stabilize the large, highly persistent structure that is now exposed from approximate station 1332+00 to the east end of Jenkin's Knob, around station 1338+00. Drilling for upcoming blasts was being completed to the west of station 1335+00 and access from the east is too steep for the rock anchor drilling equipment to begin work. While we were on-site, an excavator and a dozer walked up the steeply inclined east ramp to begin building the ramp at a shallower angle so more equipment can access the area.

Figure 1. A photograph showing the Type H Rock Dowel layout from approximately station 1335+00 to 1336+20 at approximate elevation 2610 MSL. Note the previously installed Type H Rock Dowels on both sides of this most recent layout.

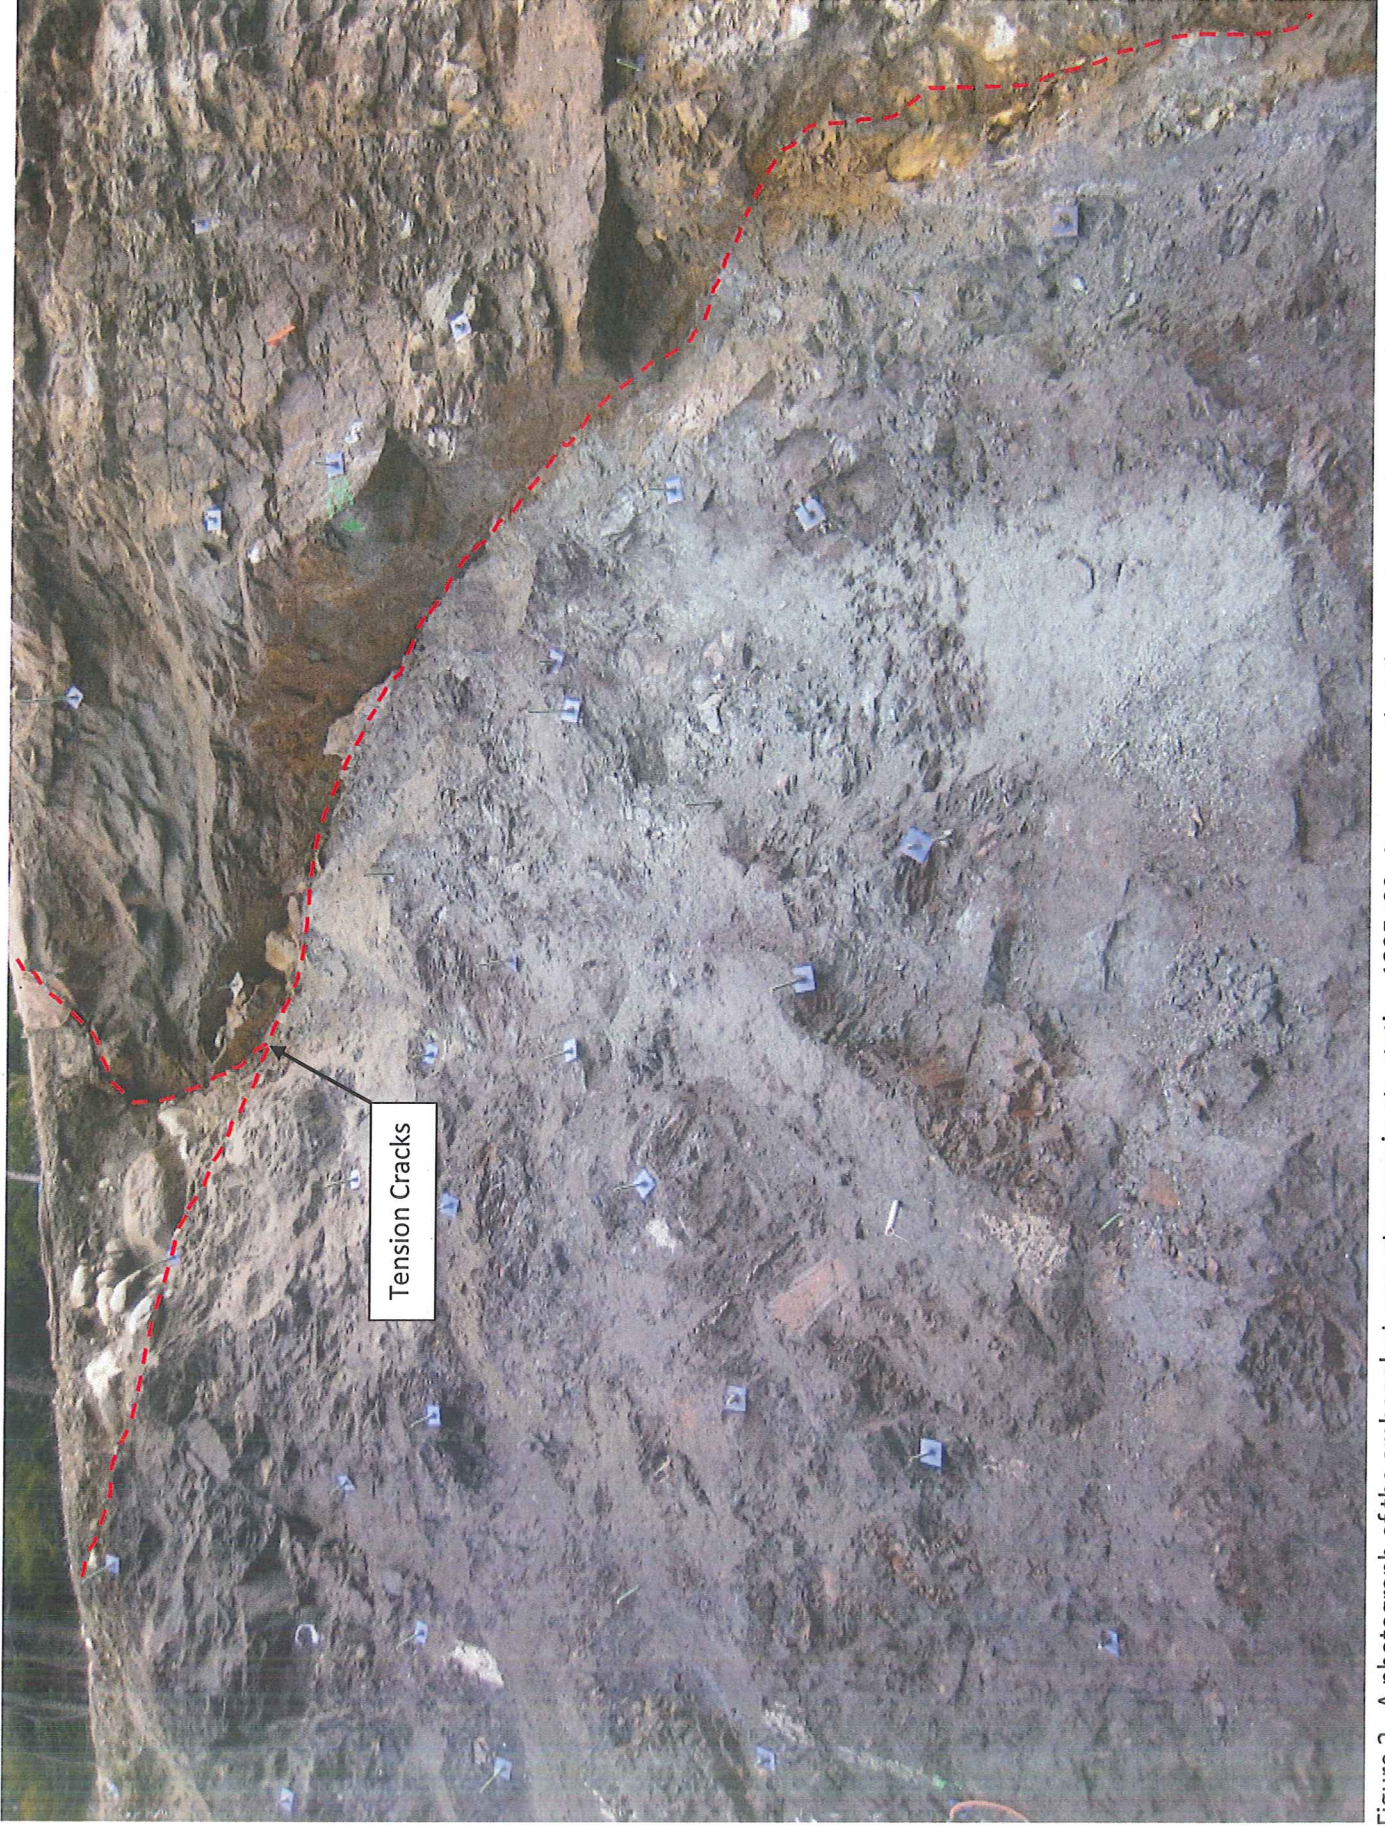
Brad indicated that the amber alert area around station 1325+00 continues to fail with approximately 10 to 15 cubic yards of material surficially failing due to the heavy rains over the weekend. Brad also stated that the tension cracks in the face appear to be widening (Figure 2). A second tension crack is beginning to develop upslope, behind the detached area that is of concern and most likely needs to be scaled (Figure 3).

Figure 2. A photograph of the amber alert area at approximate station 1325+00. It appears that the tension cracks are getting wider.

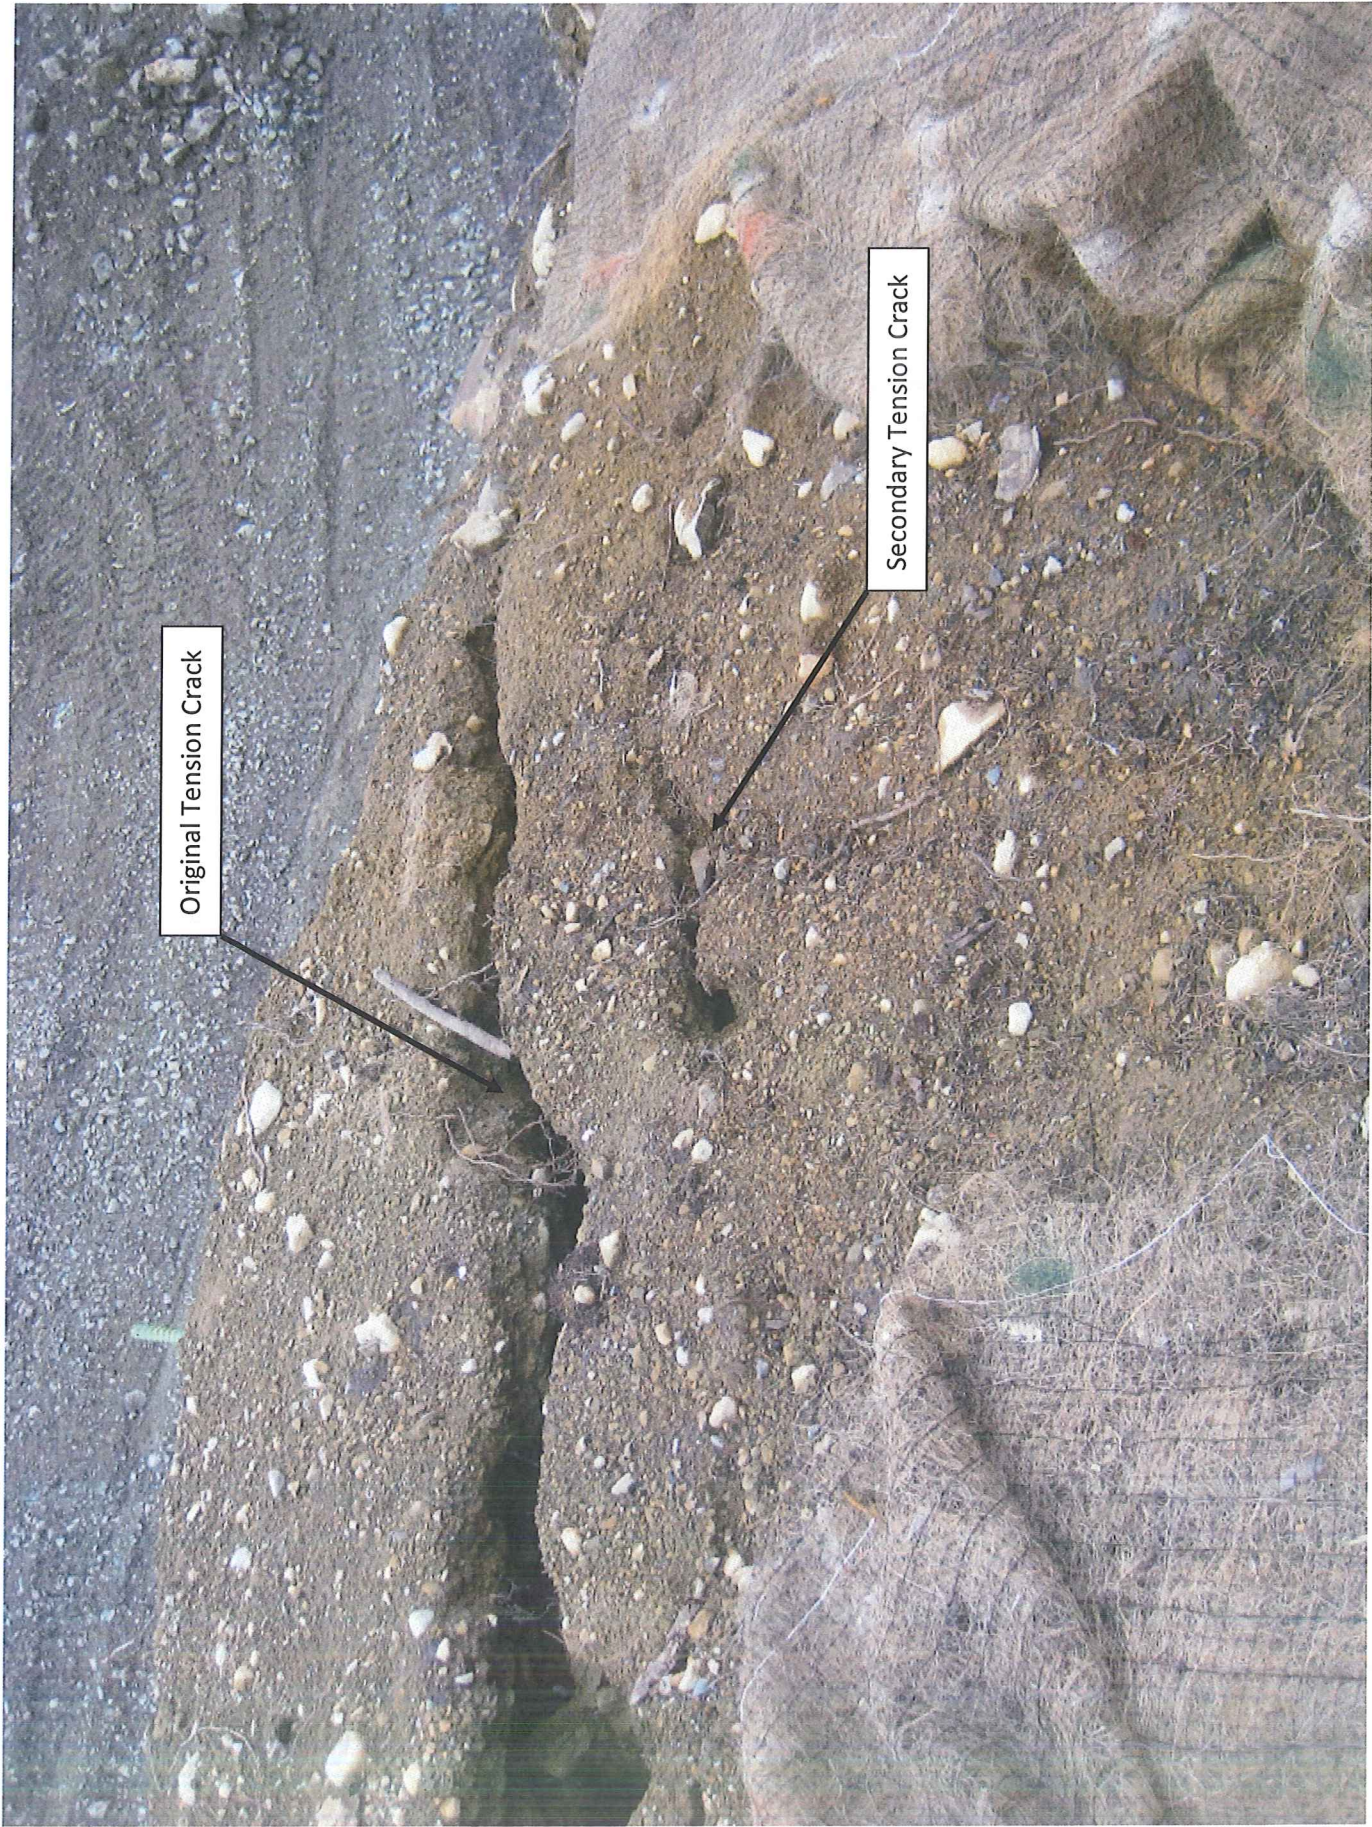
Figure 3. A photograph showing the tension cracks upslope at approximate station 1325+00. Note that a second tension crack is beginning to develop.
